Fire Station No. 11

Historic Structure Report

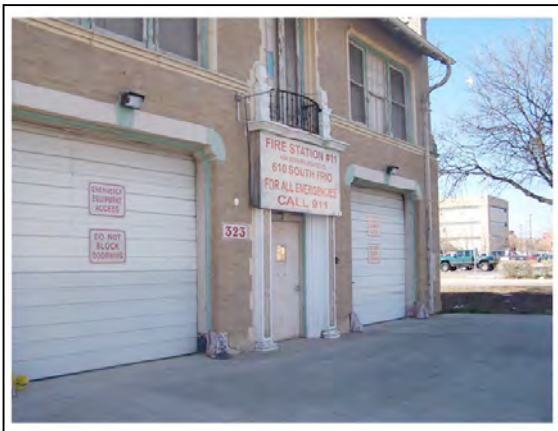
Figure 16: A temporary sign installed when the fire station was deactivated covered the upper door area for several years until removed in 2008. Current signage located on the bay doors indicates the historical use of the building as an active fire station.

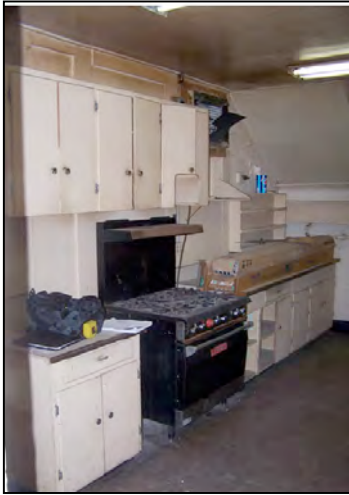
Figure 18: Current cabinetry does not appear to be part of the first build, but further investigation is needed.

Visual inspection of the south wall between the kitchen and bay indicates that it has been reconfigured some time after the 1925 construction. (See Chronology of Development and Use for more information.) This wall may have been reconfigured to allow for installation of the cabinetry and counters and to make space for a larger stove. A small pantry area off the kitchen likely provided food storage space. This also may explain the break from the symmetrical placement of doors in this area. No historical photos of the interior of the building have been located at this time. The features and historical configuration of the space might be chronologically dated through paint analysis. Further investigation beyond the scope of this report would be necessary.

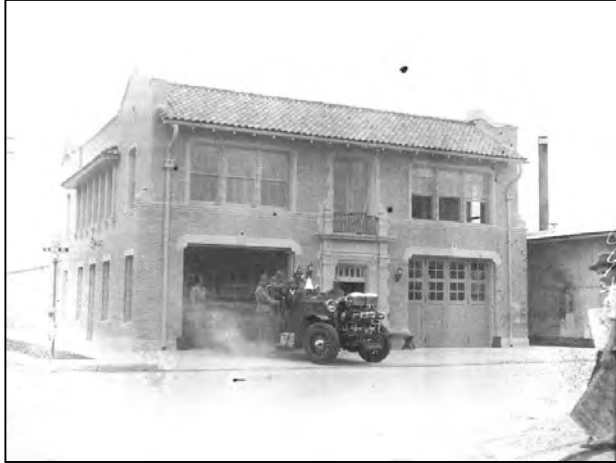
Figure 20: Fire Station No. 11 in 1925. Note red tile roof, bi-fold doors and roof drainage system. (ITC/San Antonio Light Collection)

The replacement of the 1925 red tile roof material with asphalt shingles, likely due to maintenance and budget reasons, also diminishes the historical integrity of the exterior as do changes in exterior lighting. The window screens that are currently installed on some windows do not appear in the 1925 historical photo but are evident in a 1944 photo. (Figure 15) Further investigation would be needed to determine if the metal windows installed on the north façade are part of the 1925 construction or were installed in a later renovation.

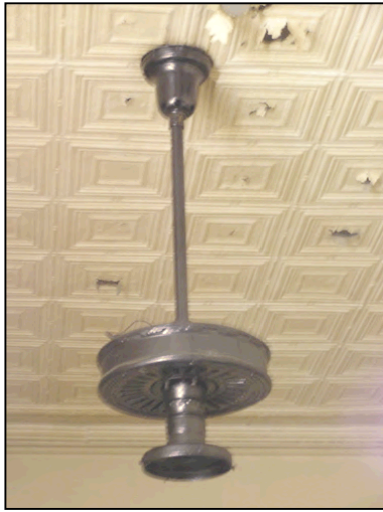
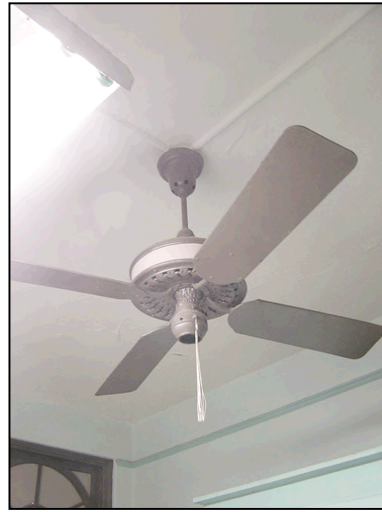
Figure 21: The ceiling fan in the joker stand area appears to be consistent with a ceiling fan identified as part of the 1925 construction of Fire Station No. 9, one of the four sister stations to No. 11.³

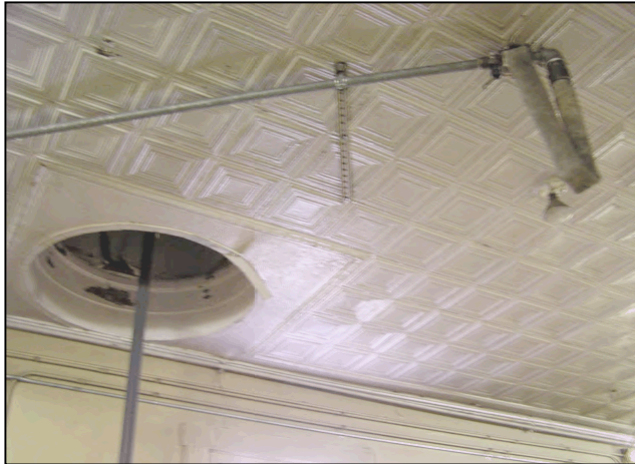
Figure 22: A pressed tin ceiling exists in the first floor apparatus bays, entry/joker stand and kitchen areas. This ceiling appears to be part of the first build because all subsequent alterations were modest, utilitarian improvements.

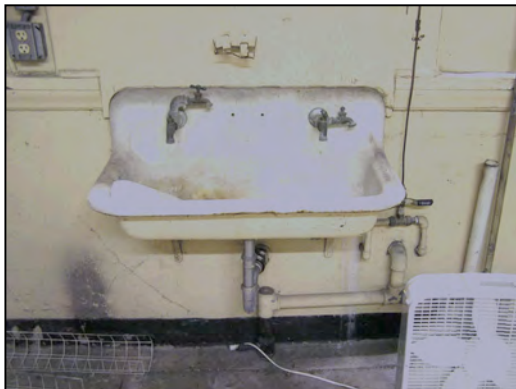
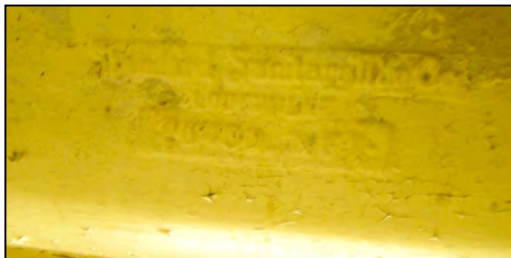
Figure 23: Cast iron sinks marked “Standard Sanitary Mfg. Co.” located in both apparatus bays are assumed to date from the first build, as well. (See Chronology of Development and Use for further information.)

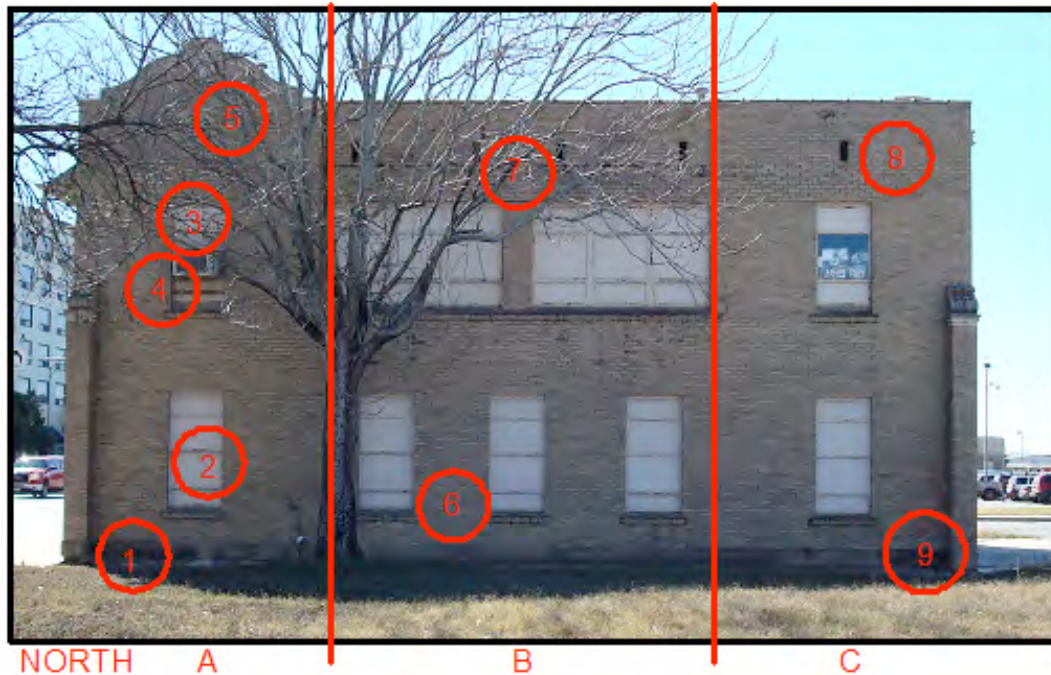
Figure 41: North Façade

1. Brick buttresses with decorative cast stone scrolls are found at both corners of the north façade. Organic growth is present on bricks adjacent to both buttresses. The sidewalk has settled significantly at the northeast corner.
2. The windows on the first level are all awning metal frame windows with four lights.
3. The second level windows are all awning metal frame windows with three lights.
4. This window has an air-conditioning unit that has altered the appearance of the window with wooden planks as reinforcements.
5. This section is the only one with a rounded decorative parapet. This is the section with a cast stone vent.

8. The vents in both the central and side sections (C) are small, rectilinear, metal vents.
9. The buttresses have a concrete base. The underlying red brick footing is exposed. The sidewalk has settled at the northwest corner, although not as much as at the northeast corner.

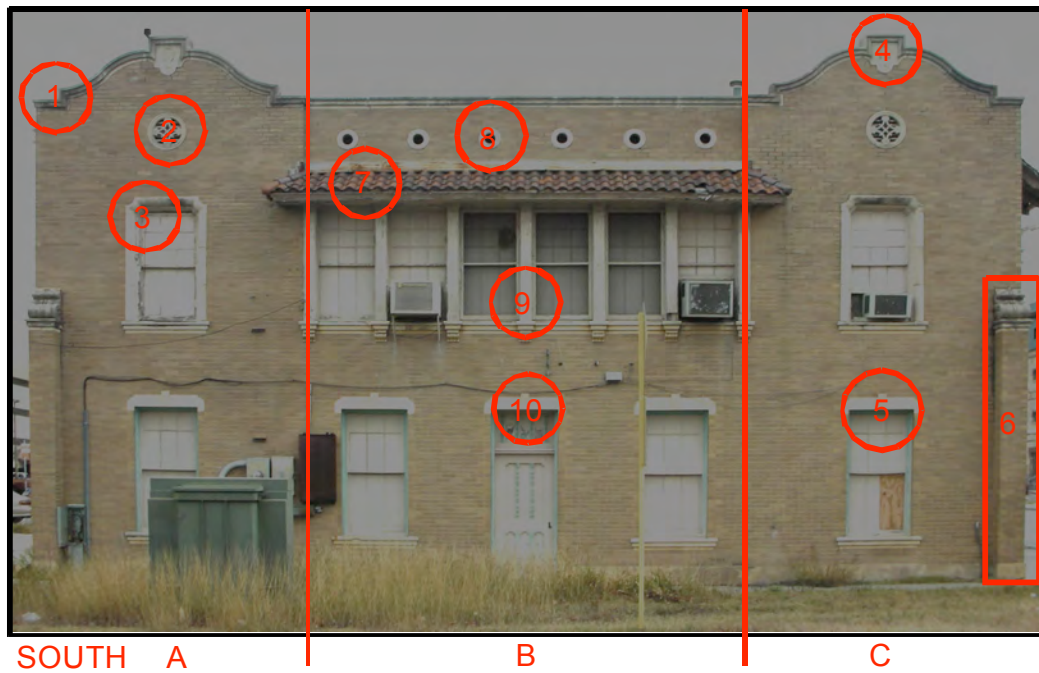
Figure 42: South Facade

7. A roof extends over the 6 windows in the central area. It is wood frame construction with a red tile roofing material.
8. Circular vents made of stone and screened
9. Six double-hung windows that are divided by square wooden columns that protrude from the rest of the façade. The bases of the columns are stone supports that coincide with the sill running along the bottom of the windows.
10. The entry door is centered within the façade. It has the same lintel as the windows on the first floor and a decorative transom. There are decorative woodcarvings on the front of the door. The trim is painted a mint green color.

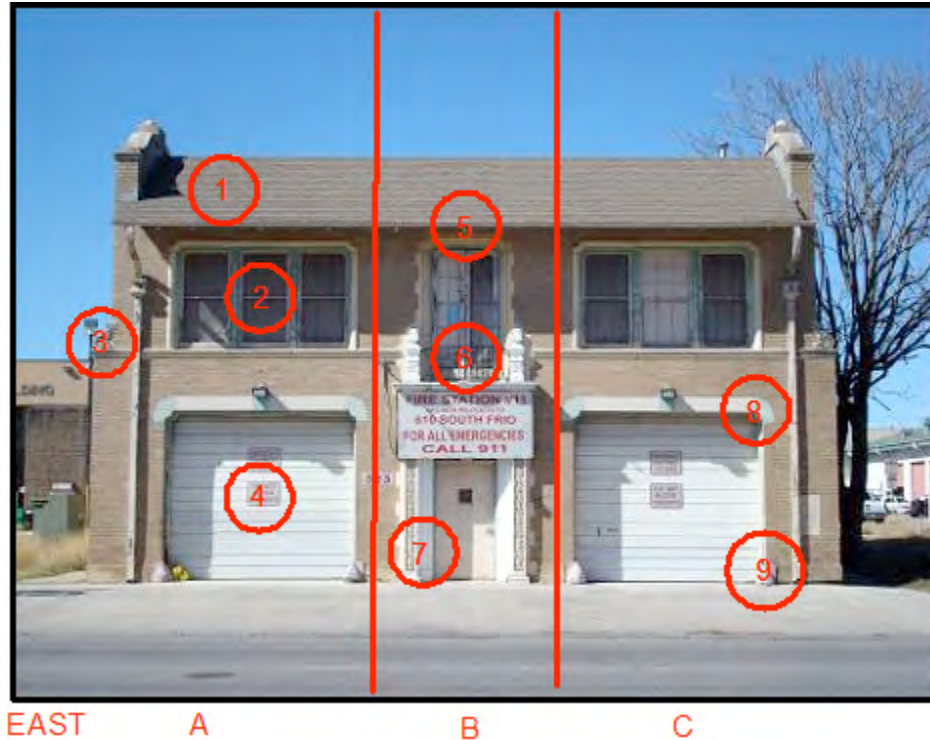
Figure 43: East Façade (front street elevation)

8. Decorative stone trim elements around apparatus doors painted mint green and cream.
9. Cast iron corner guards located at corner of each apparatus door openings.

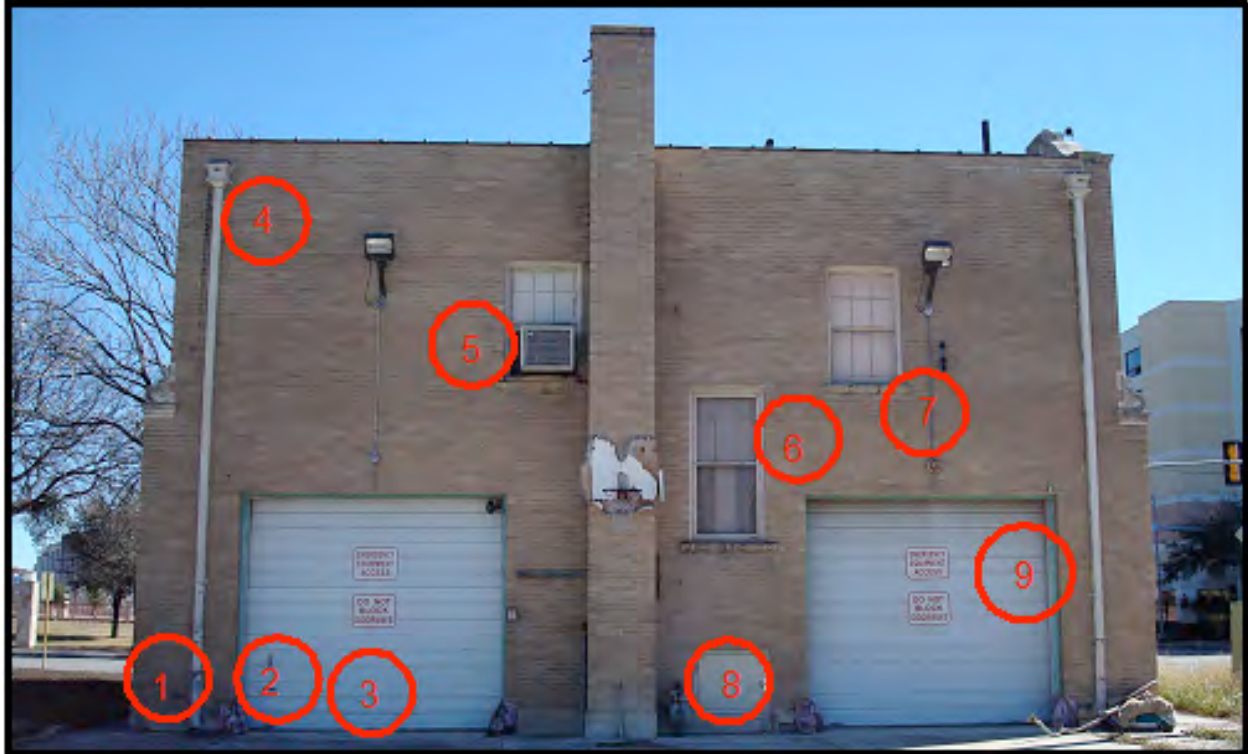
Figure 44: West Façade

1. At the north corner, the concrete base has broken off and exposed the underlying red brick.
2. The painted cast iron corner guards have started to peel and rust. They are starting to detach from the exterior wall. The wooden door frame is painted a beige and mint green color.

3. Concrete cracks are visible at the garage door exits and corner guards.
4. Painted, galvanized-metal downspouts are located on the sides of the façade and have peeled to expose the sheet metal. The sheet metal boots have peeled and rusted. A black stain is located on the upper left hand side of the building.

5. This 9-light wooden frame window has an air-conditioning unit.
6. The staircase window is composed of 9 lights and 2 lower lights are missing. The missing window lights are replaced with wooden boards.

7. The second level brick window sill has some mold and discoloration.
8. The exterior gas meter and exterior pipes are rusted.
9. The wooden frames for the garage doors are starting to peel. This exposed wood is deteriorating and chipping.

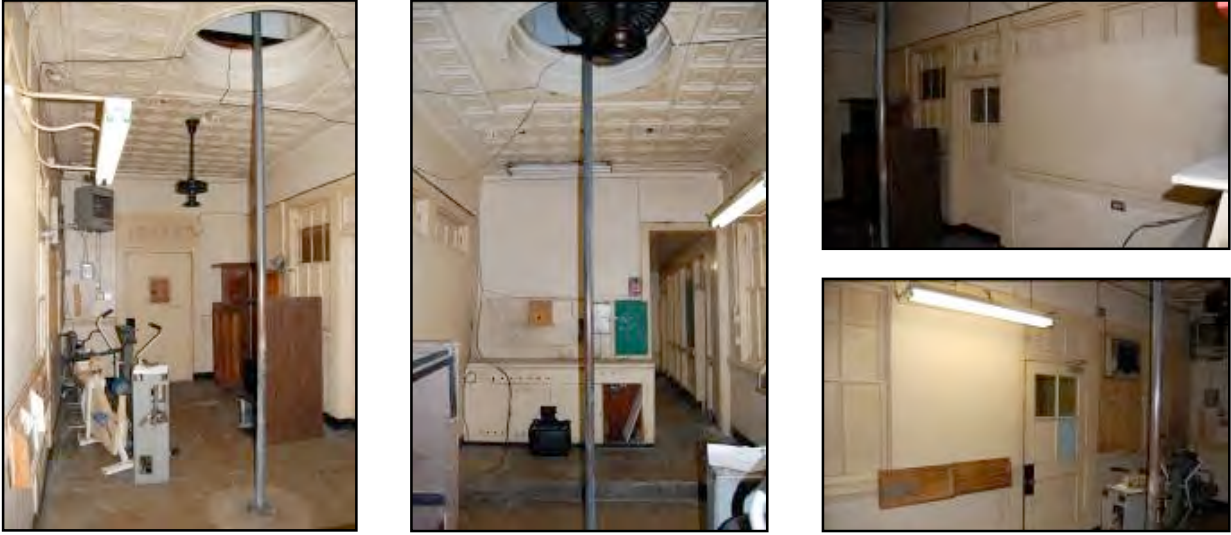
Figure 45: Joker Room Area

- The decorative tin ceiling, a popular element from the 1890's through the 1920s, is painted white. Tin ceilings are durable, lightweight and fire resistant. Rust stains are apparent.

- Two fluorescent lights and a fan are in the joker room. A/C window unit and furnace located on east walls. Electrical wiring conduit is mounted on surface of walls.

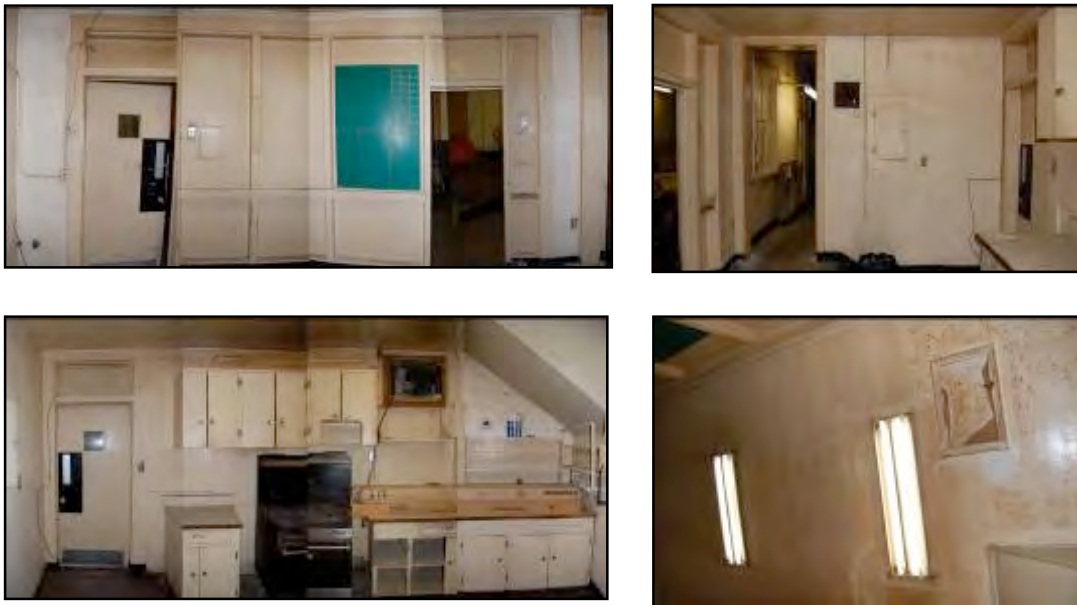
Figure 46: Kitchen/Dining Area

- The gypsum board ceiling is dropped down for the mechanical storage and the access panel allows visibility to the tin ceiling above, which appears to have rust stains in various locations.

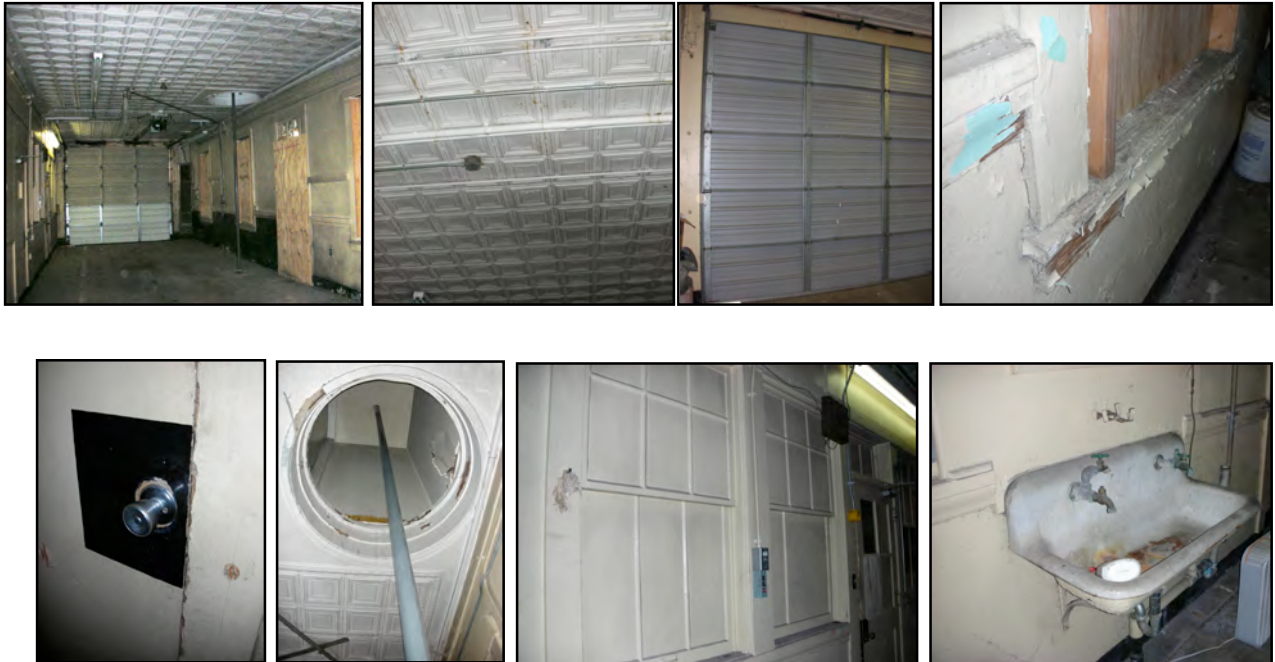
Figure 47: South Apparatus Bay Area; Similar Conditions in North Apparatus Bay

- Large metal garage doors, two on the east wall, two on the west wall, all essentially identical. There are switches attached to the wall that control the door. There are many layers of paint on the sills and trim, including mint green and light grey paint. The paint is peeling and the wood is splitting. At the door leading to the central dining room, there is a metal doorknob that does not match the other doorknob on the other interior door (Figure 47). The door leading outside is covered with a piece of plywood. Windows on the interior of the bay look into the joker room. They are painted over with light grey paint. The doorknob of the door leading to the joker room is old and fragile. An A/C unit is located near the east bay door.

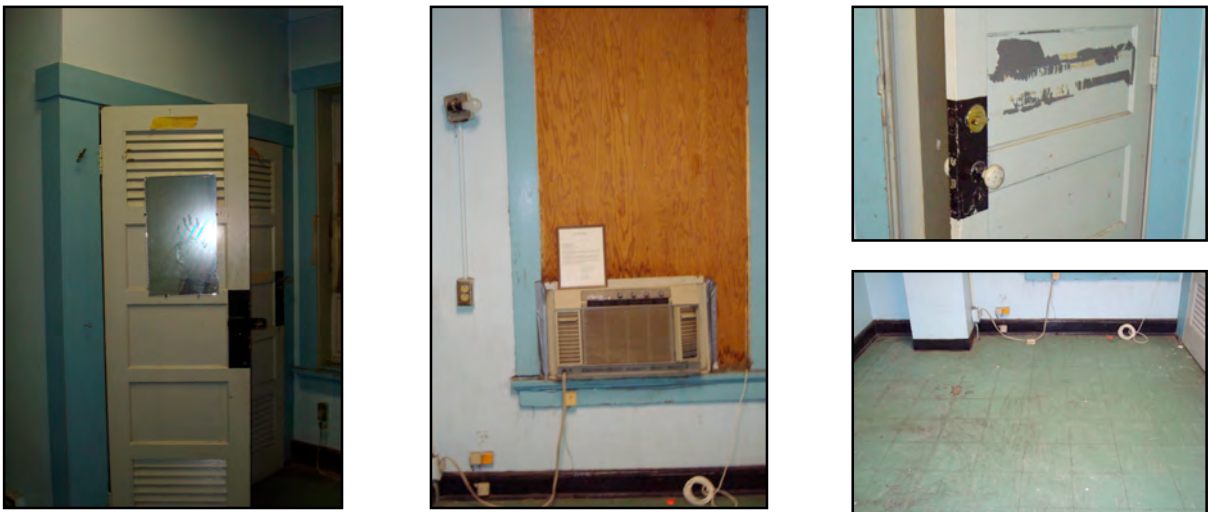
Figure 50: Offices; Similar Conditions in all Offices

- The wooden planks that encase the A/C units are deteriorated. Cracks appear in the walls of both corner offices.

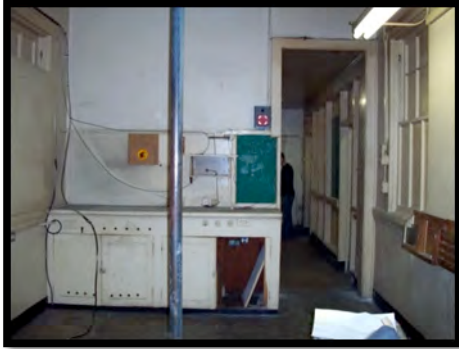
Figure 56: Fire pole can remain because it is a character defining feature, if there is a clearance of 32" for wheelchair to pass.

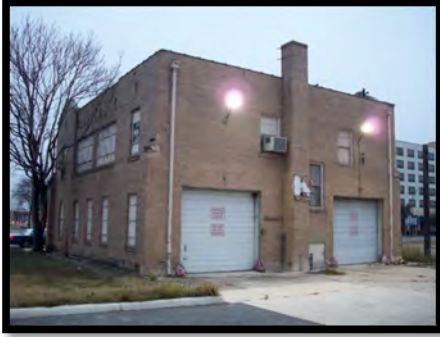
Figure 59: If main entrance is to be on west façade, it should have accessible parking in proximity to main entrance. UTSA nearby parking can serve as accessible parking for shop.

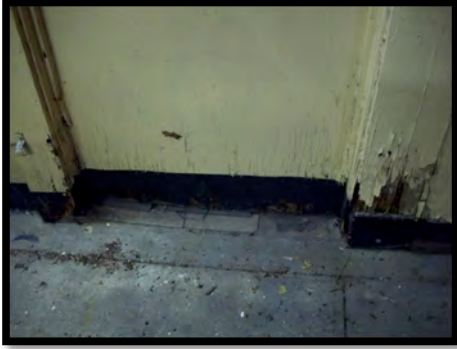
Figure 60: Floor shall be verified on site for any changes in level, for example from kitchen area towards left/right bay. The change in level shall be softened with a ramp.

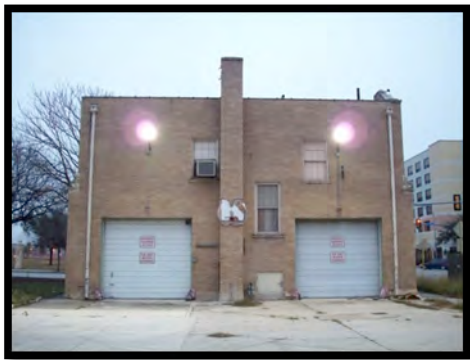
Figure 61: If parking is to be provided, the total number of parking spaces for this building will be approximately 1-25, which means at least one accessible parking space will be required. However, parking is not necessary since there is parking readily available at the UTSA Monterrey Building.

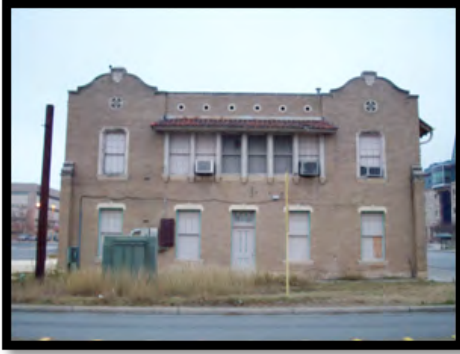
Figure 70: South Frio Street. Building has an existing bus stop that can be used to the advantage of the proposed coffee shop in the certification process.

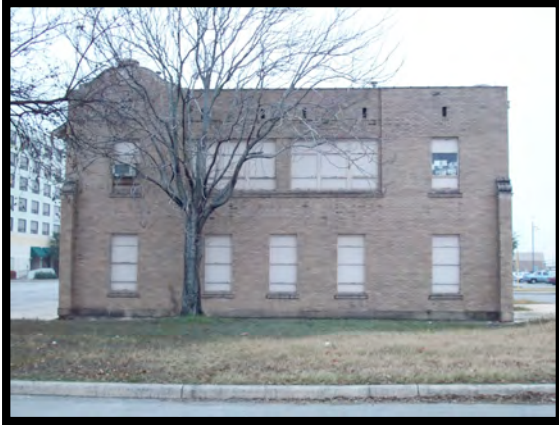
Figure 72: Use parking adjacent to serve the building. Handicapped parking spaces can also be from the UTSA Monterrey Building.

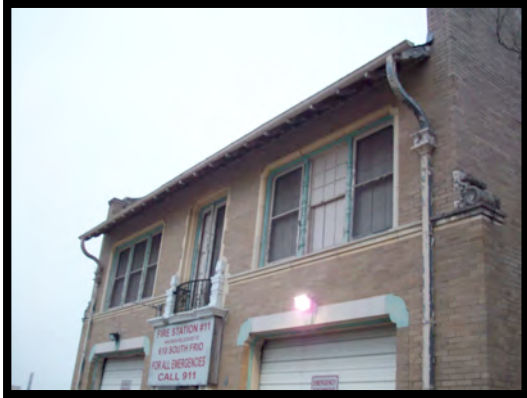
Figure 78: The existing roof decking, walls and windows will remain on the building and be reused.

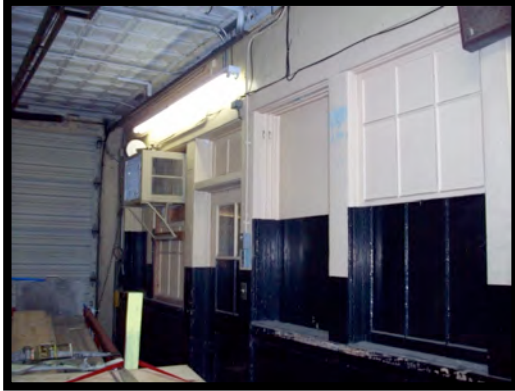
Figure 79: At least 50% of interior walls, doors floor and tin ceiling will remain intact for the proposed use of the coffee shop.
